Illinois Commerce Commission
Assessment of AmerenCIPS'
Reliability Report and Reliability Performance
for Calendar Year 2004

Pursuant to 83 Illinois Administrative Code 411.140

November 14, 2005

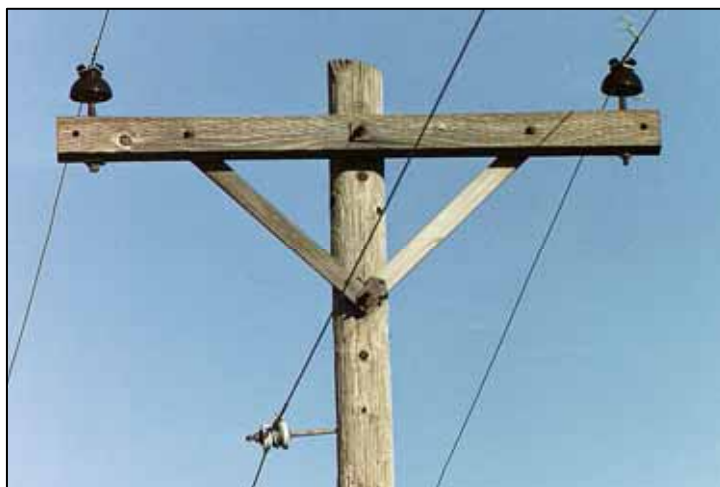
Figure 1 (Photo 05B1)
Spool bolt coming out of pole,
Circuit X81555, north of Tuscola

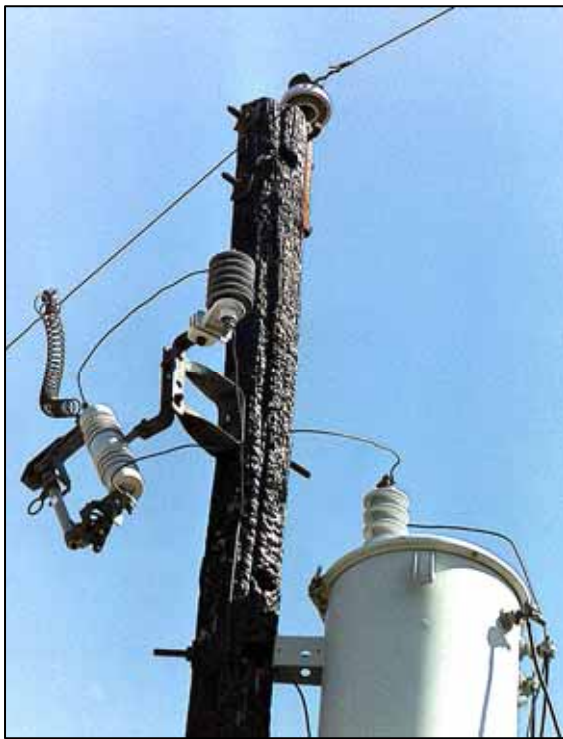
Figure 2 (Photo 05B3)
Burned pole top (lightning damaged?),
Circuit U39541, Main & Maple Sts., Timewell

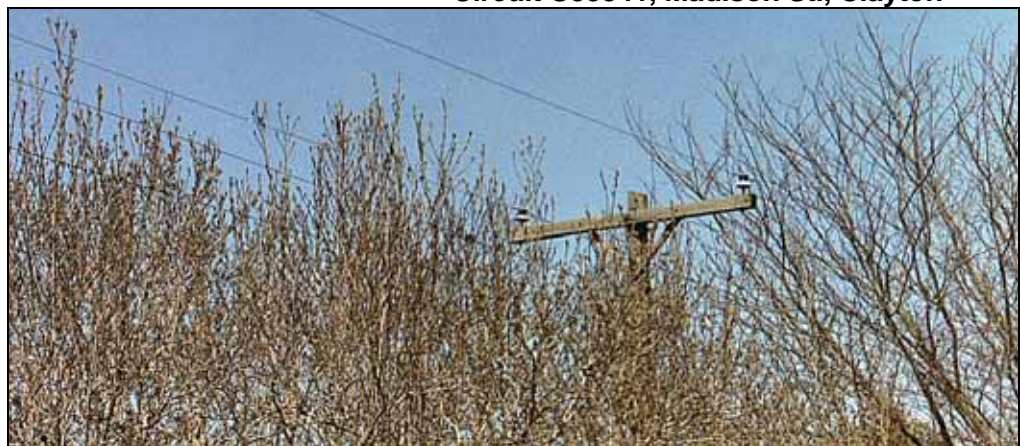
Figure 3 (Photo 05B6)
Trees into primary,
Circuit U39541, Madison St., Clayton

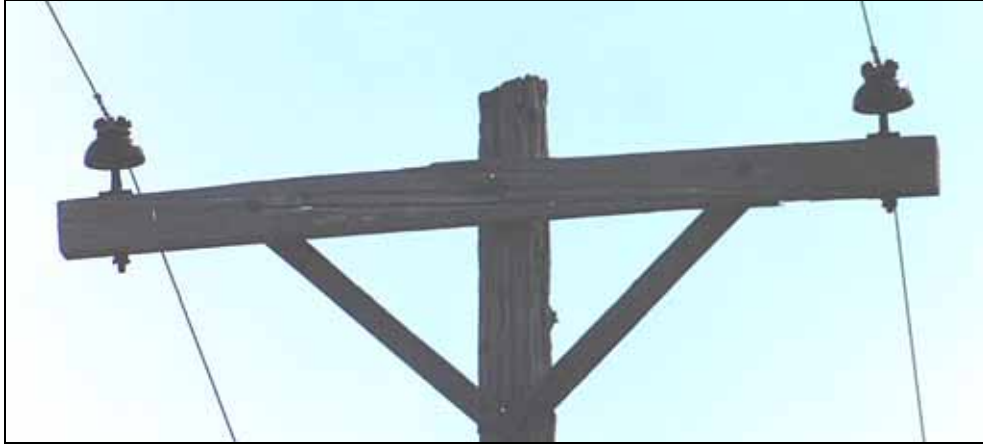
Figure 4 (Photo 05B10)
**Split & deteriorated crossarm and badly shell rotted pole,
Circuit U39541, southeast of Golden**

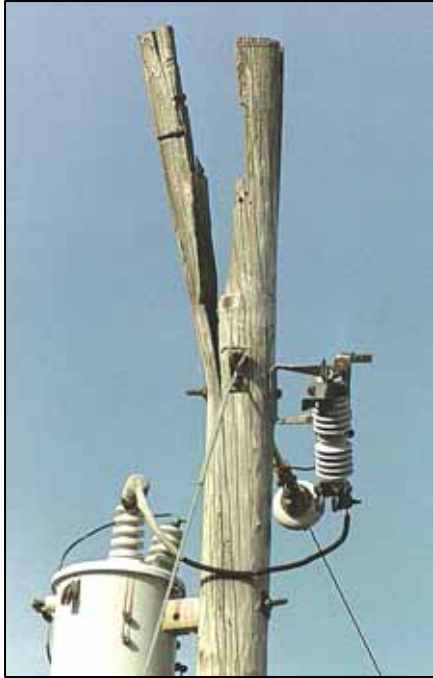
Figure 6 (Photo 05B15)
Badly split pole top,
Circuit V79594, northwest of Barrow

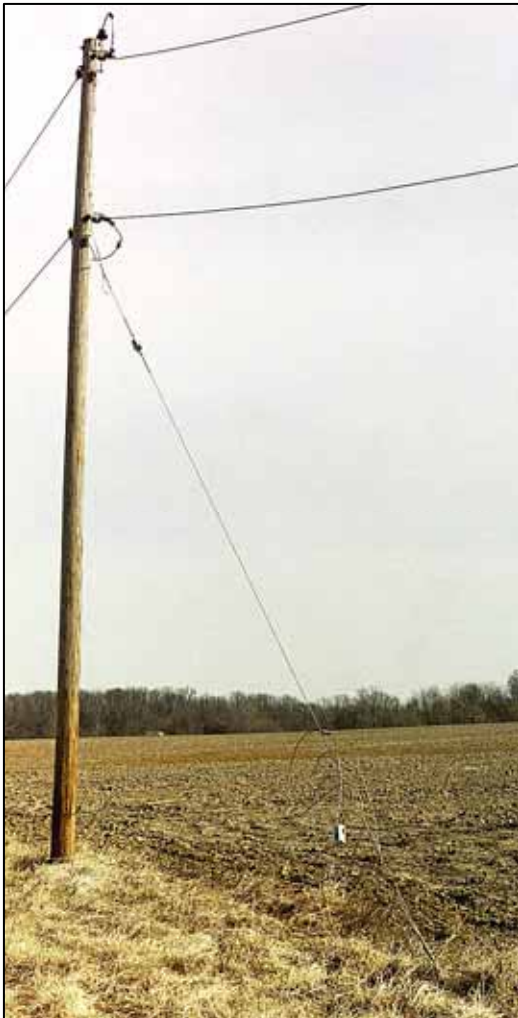
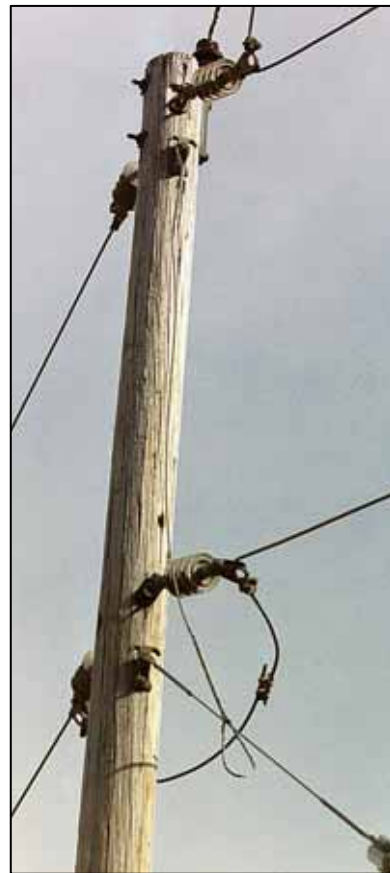
Figures 7 & 8 (Photos 05B19 & 05B18)
Broken primary downguy
(broken guy grip--possible lightning damage),
Circuit V79594, northwest of Barrow

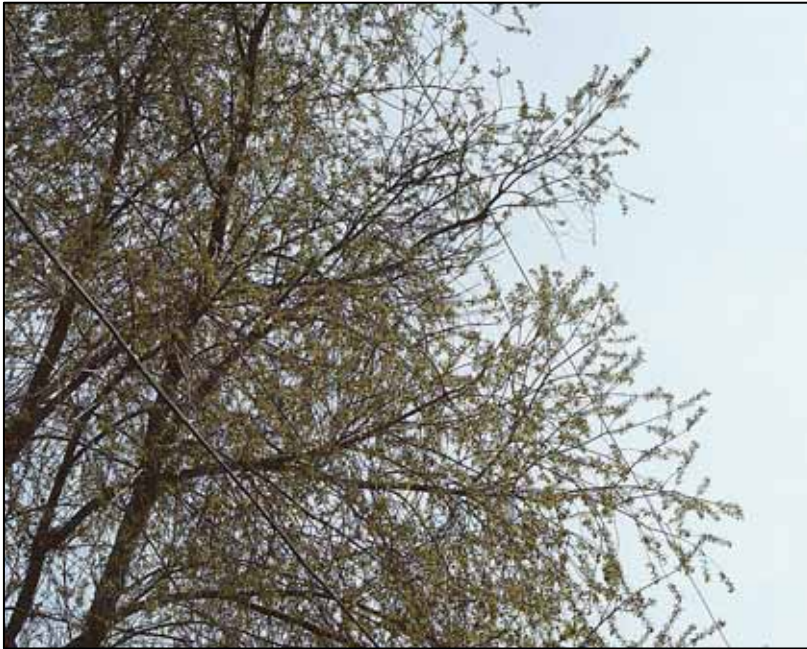
Figure 9 (Photo 05D2)
Elm tree into primary,
Cir. X96543, Lawrenceville

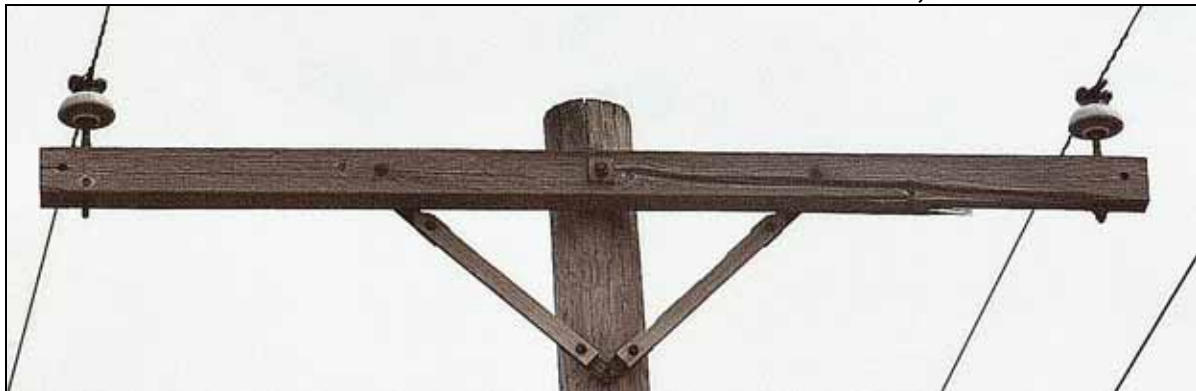
Figure 10 (Photo 05D5)
Split crossarm,
Cir. X96543, S. of Lawrenceville

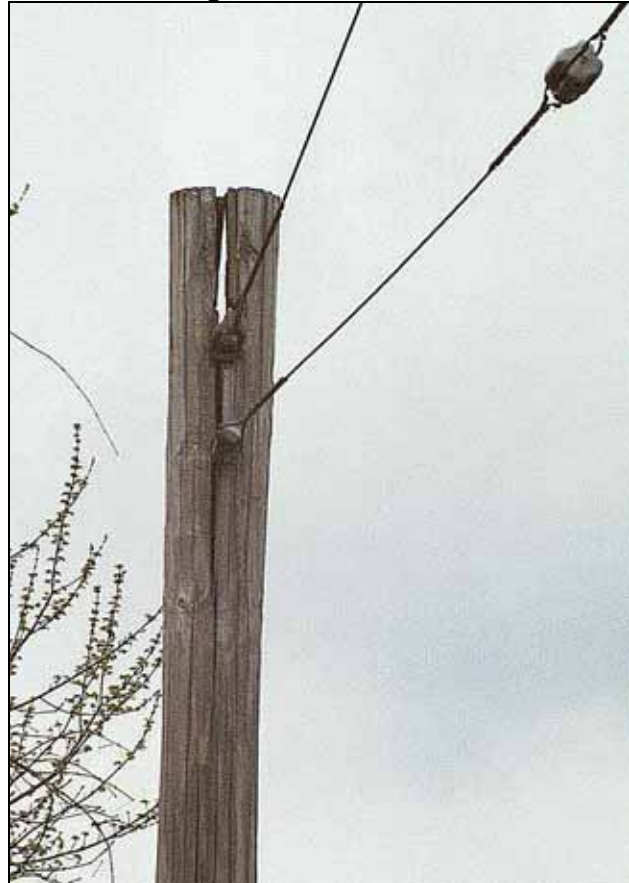
Figure 13 (Photo 05D18)
Guy stub pole badly split at top,
Circuit X96543,
9th & Meagher Sts., St. Francisville

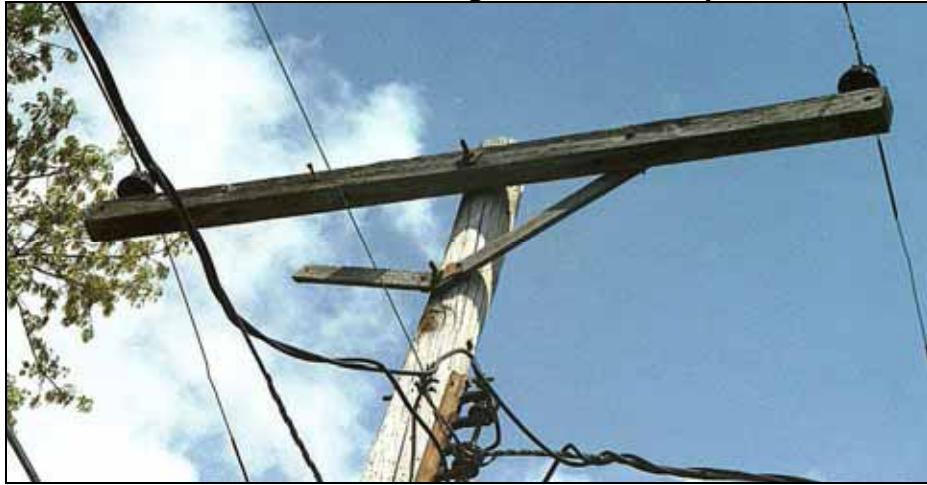
Figure 18 (Photo 05F14)
Wood brace disconnected from crossarm,
Circuit S47576, Orange St., Freeman Spur

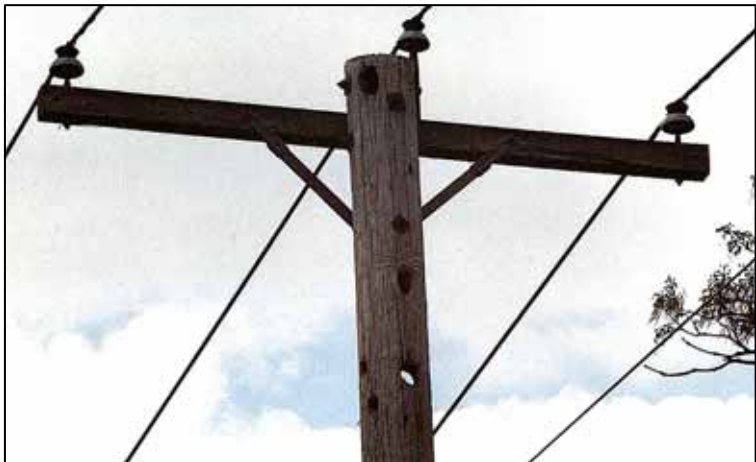
Figure 19 (Photo 05I16)
Woodpecker hole through pole & other holes in pole,
Circuit V23530, east of Detroit

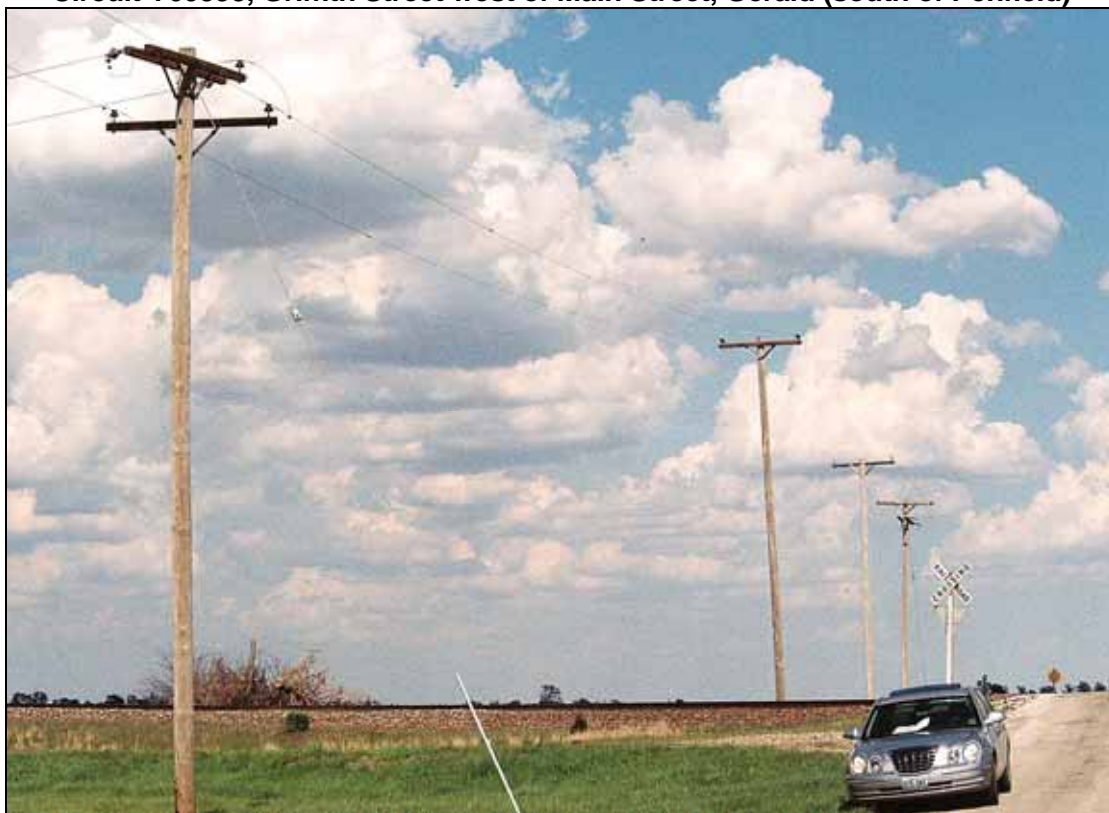
**Single wood crossarm supporting a 3-phase crossing of a railroad (double arms required),
(NESC structural strength violation)**

Circuit Y60593, Griffith Street west of Main Street, Gerald (south of Penfield)

(Double crossarms have been required for all railroad crossings in Illinois where wooden crossarms and pin-type insulators are used since General Order 10 was adopted on April 2, 1914)

Note: AmerenCIPS reported that it replaced the single crossarm with double crossarms at this location as required by the code on July 29, 2005. This location is now in compliance with the requirements of the NESC.

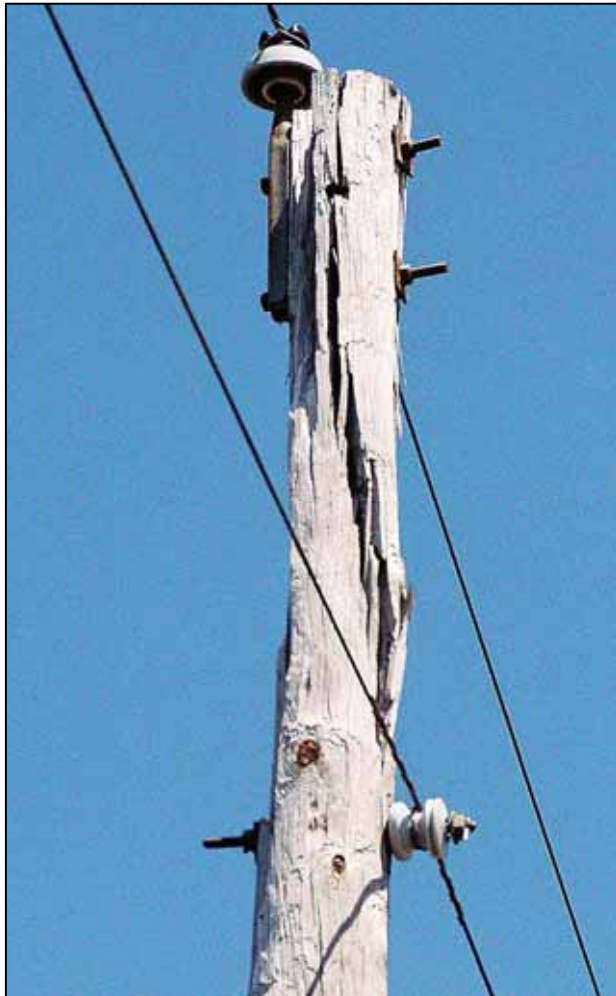
Figure 21 (Photo 05K8)
Lightning damaged pole top,
Circuit Y60593, Road 2800N, east of Rantoul

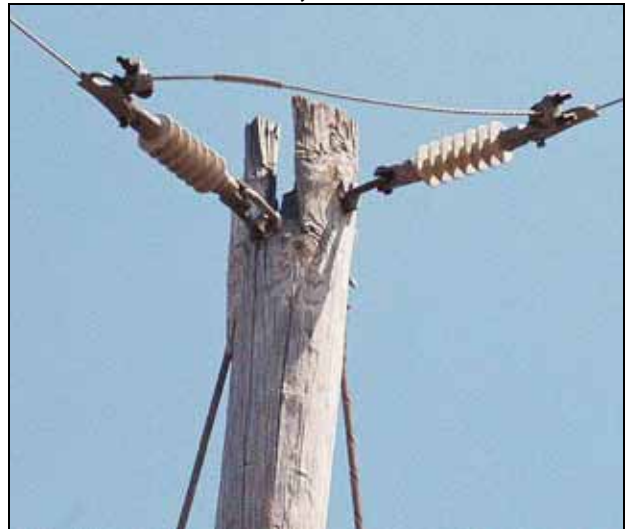
Figure 22 (Photo 05K7)
Badly split pole top,
Circuit Y60593, east of Rantoul

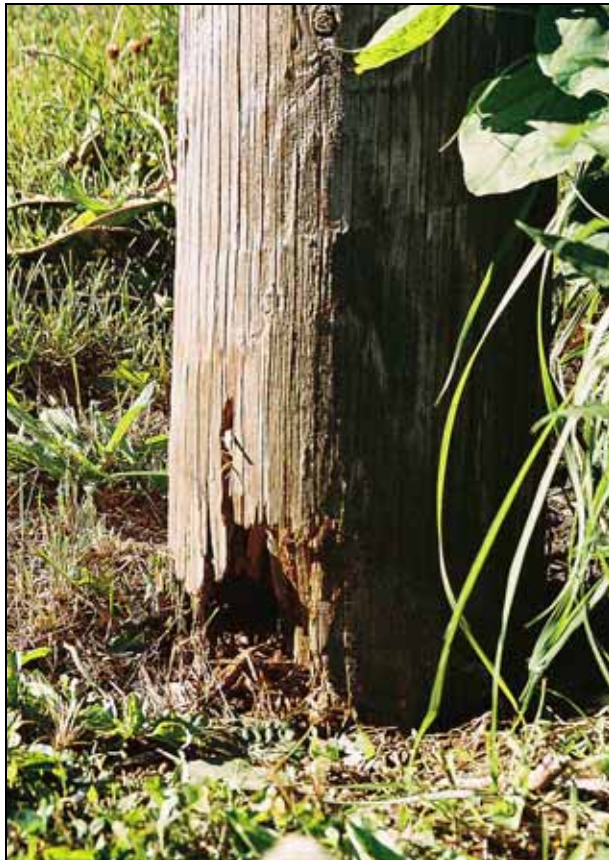
Figure 24 (Photo 05P1)
Pole damaged at ground line,
Circuit U04538, Main St. east of Jackson St.,
Pleasant Plains

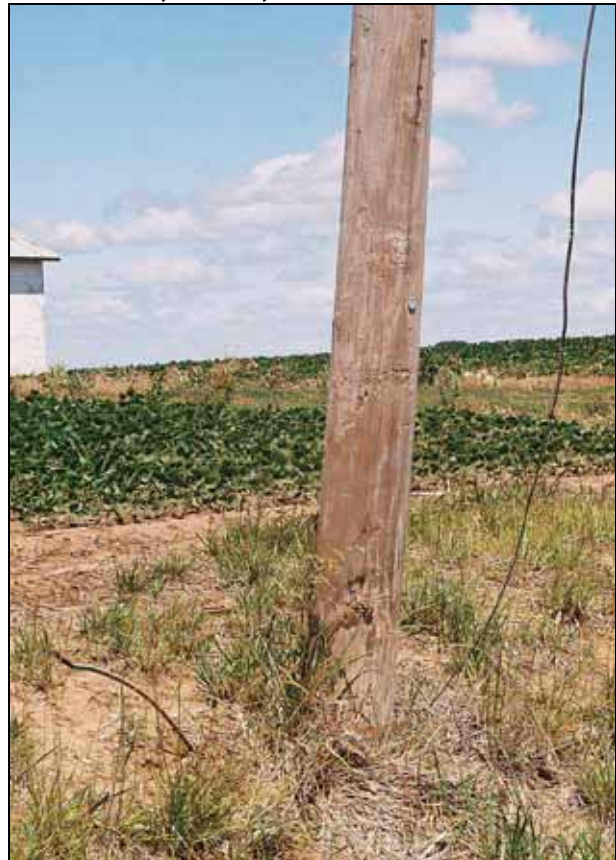
Figure 25 (Photo 05P5)
Broken ground wire & ground rod
partially pulled out of ground,
Cir. U04538, CH 9C, south of Pleasant Plains

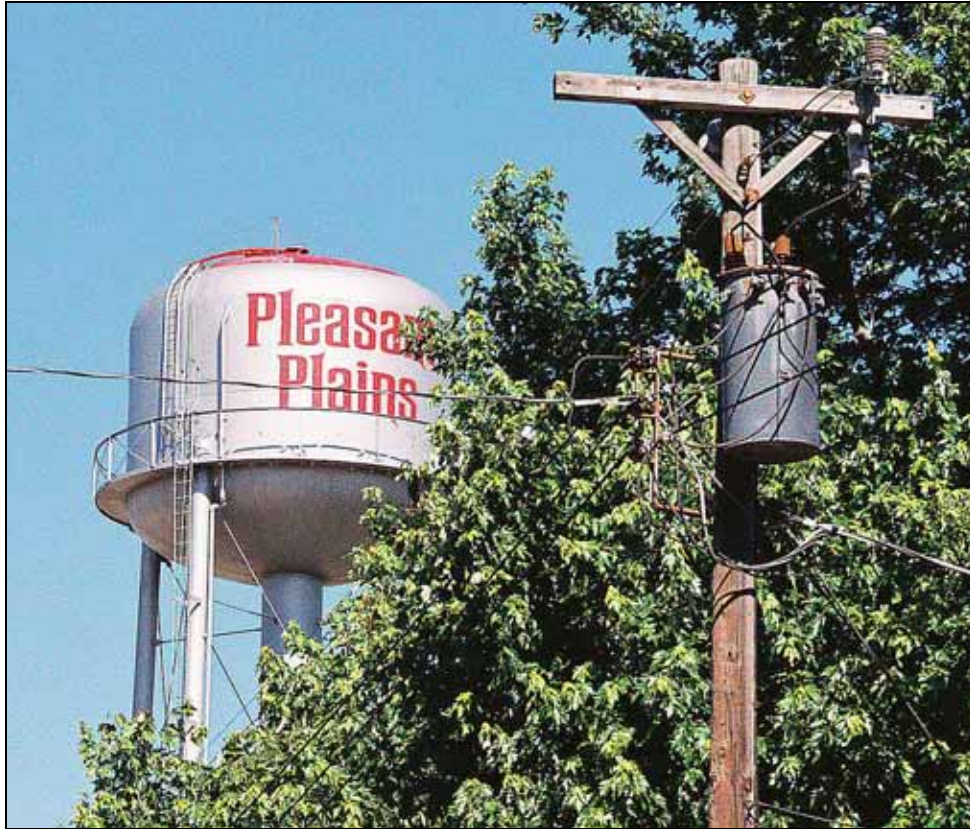
Figure 26 (Photo 05P3)
Primary burning a soft maple tree,
Circuit U04538, 4th Street east of Lincoln Street, Pleasant Plains
